TEST REPORT

REPORT NO. TH90084/2008
PAGE NO. 1 OF 6
DATE: Oct. 15, 2008

Product Description: Racing Carbon Frame
Style/Item No.: Galileo Full Carbon Frame
Manufacturer/Vendor: TAIWAN
Country of Origin: TAIWAN
Sample Quantity: 1 pcs
Sample Received Date: Sep. 23, 2008
Test Period: Sep. 24, 2008 ~ Oct. 14, 2008

Test Required: For compliance with Clause 4.8.2.2, Clause 4.8.3.2, Clause 4.8.4.2 and Clause 4.8.5.2 of EN 14781:2005 Racing bicycles – Safety requirements and test methods.

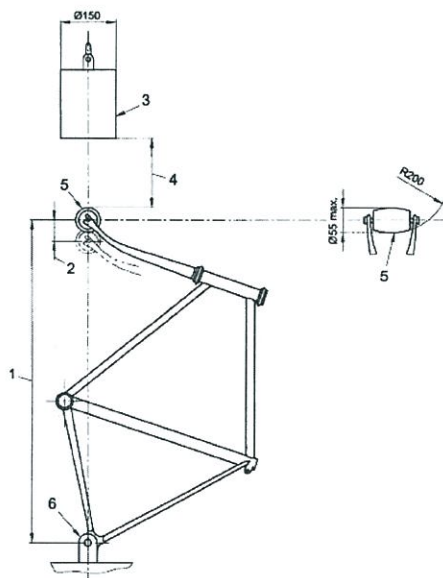
4.8.2.3 Test method

When tested by the method described in 4.8.2.3, there shall be no visible cracks or fractures in the assembly and there shall be no separation of any parts of any suspension system.

Test clause	Requirement	Test Result
Clause 4.8.2.3	< 30 mm	1.5 mm
Remark	There was no visible crack on the sample after testing.

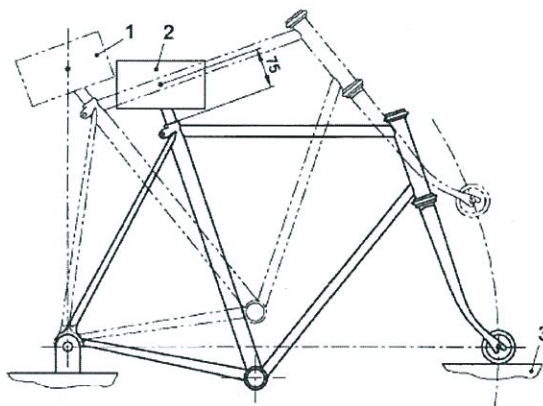
4.8.3.3 Test method

When tested by the method described in 4.8.3.3, there shall be no visible cracks or fractures in the assembly and after the second impact, the permanent deformation measured between the axes of the wheel axles (the wheel-base – see 3.23) shall not exceed 15 mm for a frame-fork assembly and there shall be no separation of any parts of any suspension system.

Test clause	Requirement	Test Result
Clause 4.8.3.3	< 15 mm	1.9 mm
Remark	There was no visible crack on the sample after testing.

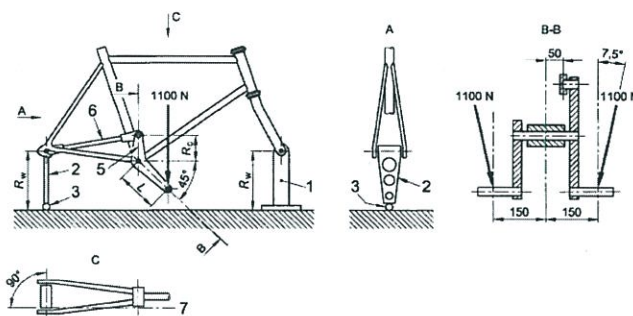
4.8.4.3 Test method

When tested by the method described in 4.8.4.3, there shall be no visible cracks or fractures in the frame, and there shall be no separation of any parts of any suspension system.

Test clause	Test conditions				Test Result (cycle)
		Force	Frequency	Cycles	
Clause 4.8.4.3	Requirement	1,100 N	< 25 Hz	100,000	100,000
	Actual	1,100 N	3 Hz		
Remark	There was no visible crack on the sample after testing.

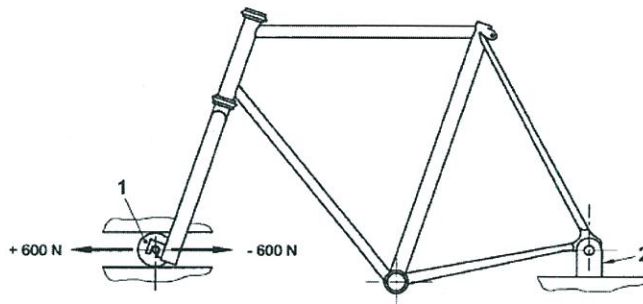
4.8.5.3 Test method

When tested by the method described in 4.8.5.3, there shall be no visible cracks or fractures in the frame and there shall be no separation of any parts of any suspension system.

Test clause	Test conditions				Test Result (cycle)
		Force	Frequency	Cycles	
Clause 4.8.5.3	Requirement	+ 600 N - 600 N	< 25 Hz	100,000	100,000
	Actual	+ 600 N - 600 N	3 Hz		
Remark	There was no visible crack on the sample after testing.

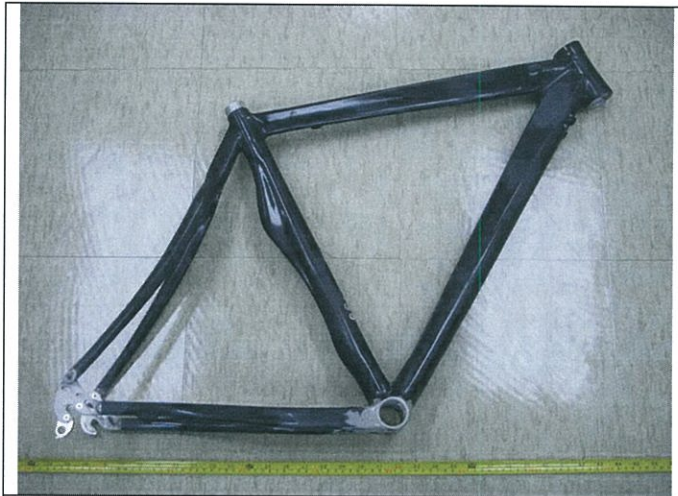
Photo "A" Appearance of sample
