Rapport Crash test UCI

TESTS REPORT Ref: 9-4092

CONCERNING: <u>IMPACT TEST ON BICYCLE WHEELS</u>

Client reference: Wheels Pro-lite Vicenza

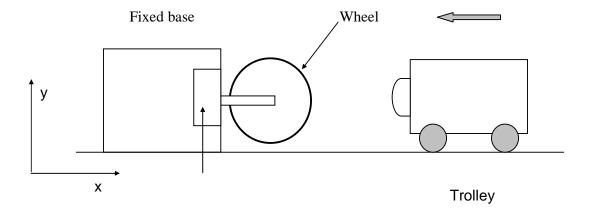
The testing facilities is made up of a little trolley moving at controlled speed and impacting the wheel to be tested. The wheel is fixed on the testing machine base.

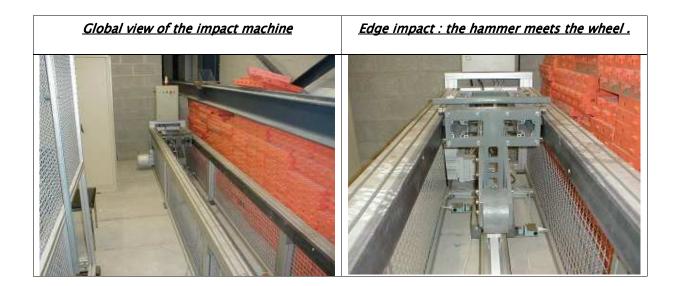
Positions of the impact point in the two types of tests

- The trolley touches the wheel at mid-height. This represents a front impact (A).
- The trolley touches the wheel in a lower position (B). This position is chosen to simulate what happens during an impact with the edge of a sidewalk, or in a big hole in the road. The impact point is located on a straight line making an angle of 45° with the horizontal and joining the centre of the wheel.

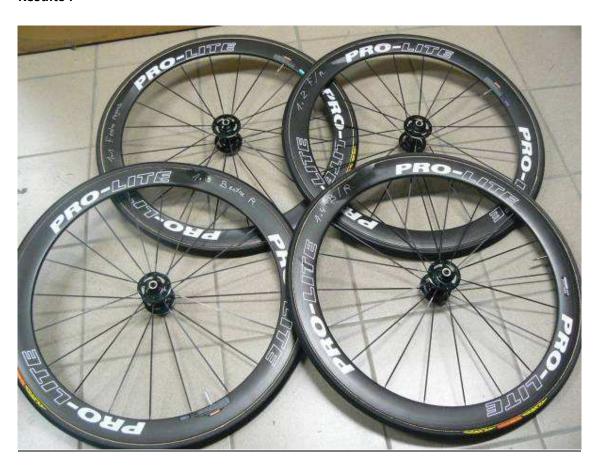
Wheels Pro-Lite Vicenza

20Aluminium spokes - length: 240mm - width 3.15mm - Thickness 1.00mm

Carbon rim ±50mm

Wheel diameter \pm 635mm

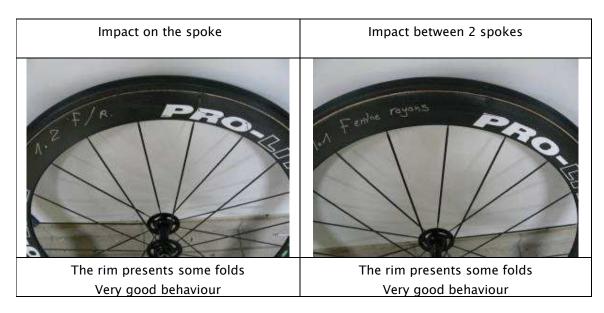
Front position

Specifications UCI	<u>Résult</u>
During the impact, no part or piece of the wheel will be ejected.	<u>Ok</u>
The fracture must not show free broken sharp parts, that could injure the rider or any other rider in contact with the wheel during the impact.	<u>Ok</u>
After the impact, the coherence of the wheel must be kept. The link between the hub and the rim must be kept, the rim and the hub must stand together.	<u>Ok</u>

The Wheels Pro-Lite Vicenza - (Carbon rim height \pm 50mm) comply with the requirements of the UCI.
